# PJ Materials Consultants Limited

Specialist Consulting Services for the Construction,  
Restoration and Protection of Concrete  
& Masonry Structures

## Project Profiles

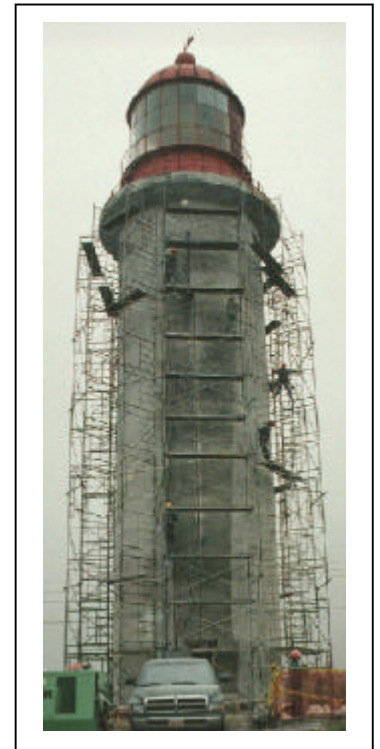
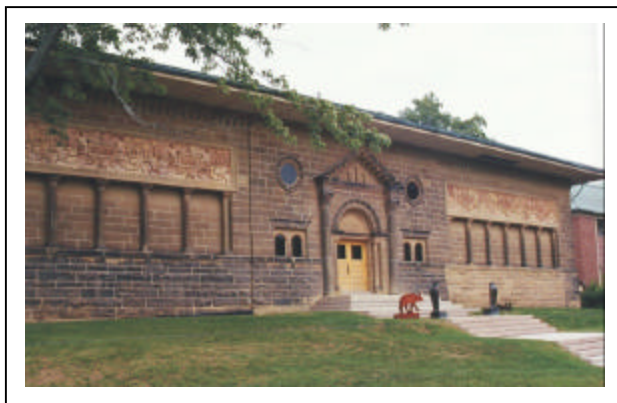
### Cape Race Lighthouse

Constructed in 1905 and situated in Newfoundland, Cape Race Lighthouse is the oldest reinforced concrete light-tower in North America. The tower underwent three major attempts at restoration in 1937, 1969 and 1983 - the first two projects based on adding an extra layer of concrete to the original tower. All of these attempts failed to address the original causes of the accelerated deterioration and damage and the tower continued to suffer the effects of cracking, freeze-thaw damage and corrosion of embedded reinforcing steel. In 1995, the tower was closed to the public due to the potential hazards of falling concrete debris.

In 1996, PJ Materials Consultants carried out a detailed investigation of the tower's condition and devised and implemented a new restoration strategy on behalf of the Canadian Coast Guard. The restoration work, which was completed in 2000, included the installation of vertical joints, installed through the outer layer of concrete, to better accommodate differential movement. The strategy also included the installation of helical stainless steel masonry ties, the repair of deteriorated concrete and the application of a breathable, water-proof coating. The strategy also included a monitoring programme which determined the appropriateness of coating the concrete after a period of forced drying.

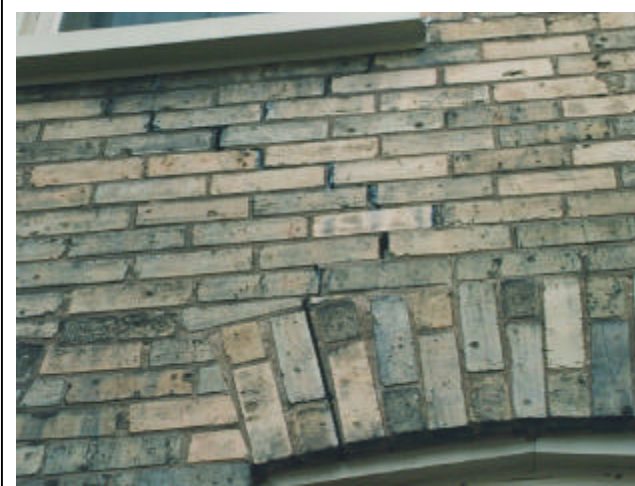
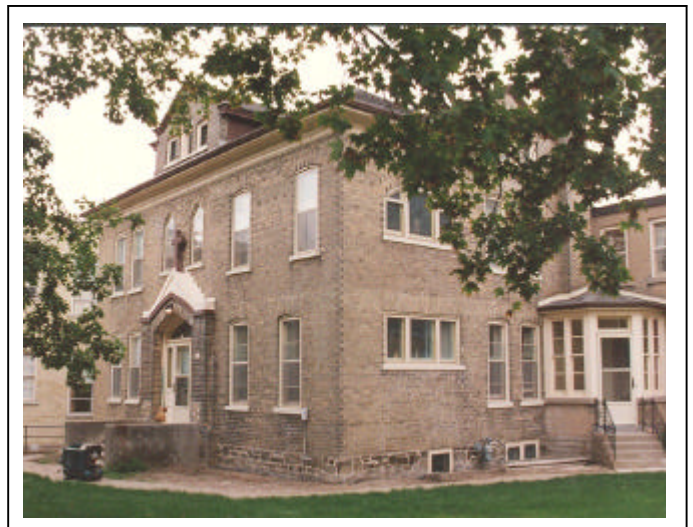
### Saint Louis Parish Church Convent, Waterloo, Ontario

This 100-year old convent suffered badly from cracks within the brick masonry and there had been many attempts at repair over the years - all of them failing, with the result that rainwater continually entered the masonry assembly.

An investigation carried out by PJ Materials Consultants determined that the most likely cause of the problem was below grade water infiltration. Rainwater was penetrating through deteriorated mortar joints in the rubble stone foundation wall to cause disintegration of the inner core rubble lime binder. This in turn was causing lack of adequate restraint to stresses developed during extremes of temperature change, resulting in differential movement and settlement, to ultimately cause the cracking problems.

A restoration strategy was devised which included below grade waterproofing, grouting of the voids within the foundations walls using a lightweight cellular foam, the installation of stainless steel masonry ties across the foundation wall and across cracks within the brick masonry and finally cutting out and repointing all cracked mortar joints. In spite of several severe winters and the extremes of temperature, the masonry has remained crack-free and the basement is now dry.
